Manhole Inspection Summary

Manhole # S37KK_022MH

Insp Date: **3/19/07 8:44 AM**

Location Address: **427 LAFEYETTE AVE**

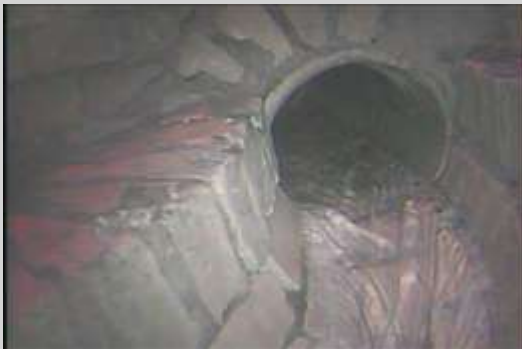
8 in. Circular Gravity Sewer Pipe In @ 3 O'Clock

Pipe Material: **Clay** ☐ Pipe Lined

Infiltration: **None** Pipe Seal Cond: **Unknown**
